Manhole Inspection Summary

Manhole # S35C__053MH

Insp Date: **8/5/08 10:03 AM**

Location Address: **rear 401 n charles st**

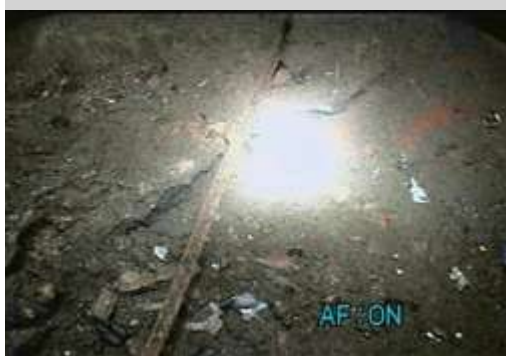
Defect 3

Condition: ☐ Sound ☐ Cracked ☐ Root Intrusion ☐ Deteriorated ☐ Leaks ☒ **Debris**

channel debris

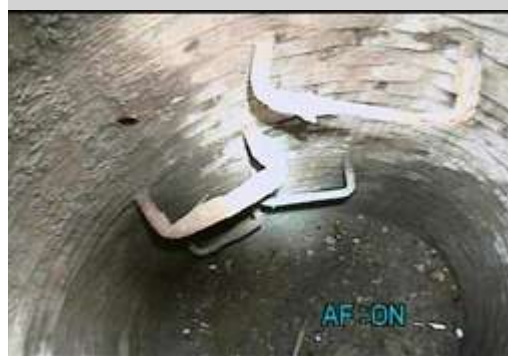
Defect 2

Steps Count: **4** Missing: **0** ☒ **Corroded**

steps

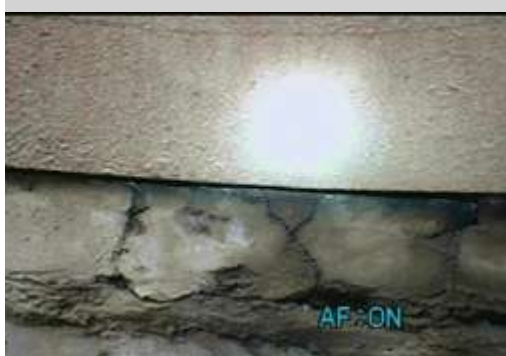
Defect 1

Condition: ☐ Sound ☒ **Cracked** ☐ Root Intrusion ☐ Loose Brick ☐ Deteriorated

Chimney cracked, frame adj
